**Flood Control Project Maintenance
Levee Inspections**

2018 Channel Summary Report

Merced Streams Group

Levee Inspection Report By Mile - Channel 2018

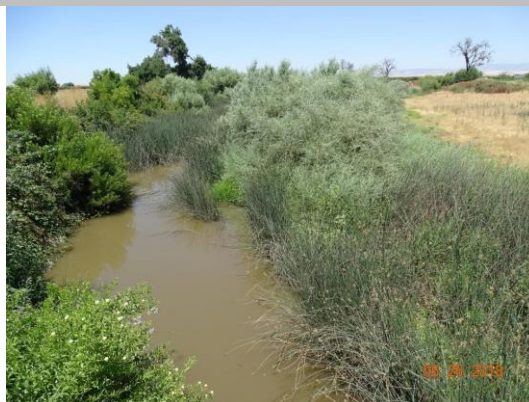
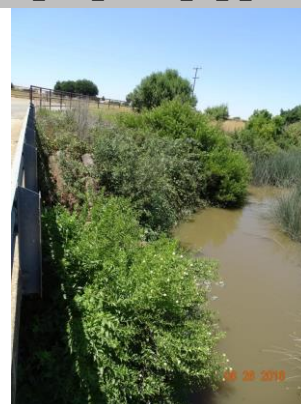
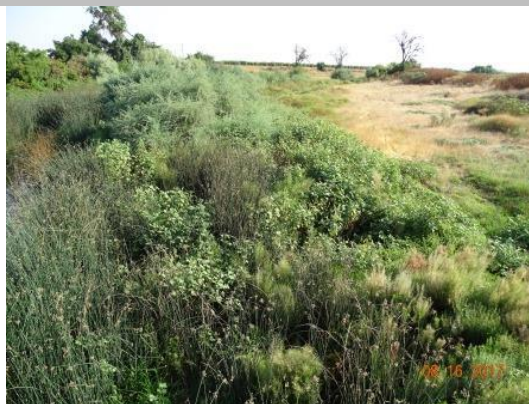
Rating **	U	Issue No.	1	GPS Lat/Long
Issue Type +	Ma	Location *		37.336900 °
Category	Rivers, Channels & Designated Flood			-120.311100 °
Item	Vegetation & Obstructions			
DWR ID	DWR_NA0013_32_c_2016_1			
Action/Comments				
Inspector Comments: Vegetation present in channel upstream of bridge crossing, flow may be impeded.

Bear Creek from Bonner Road Bridge Crossing looking upstream.
Summer 2018

Bear Creek from Bonner Road Bridge Crossing looking upstream.

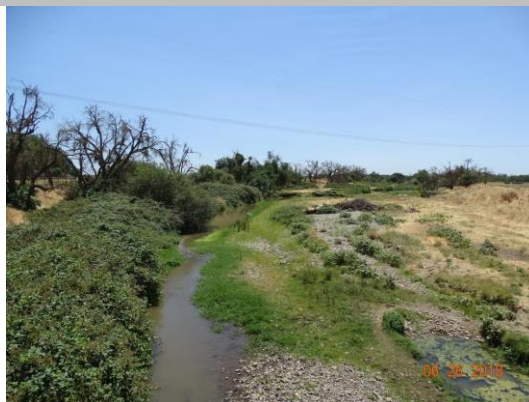
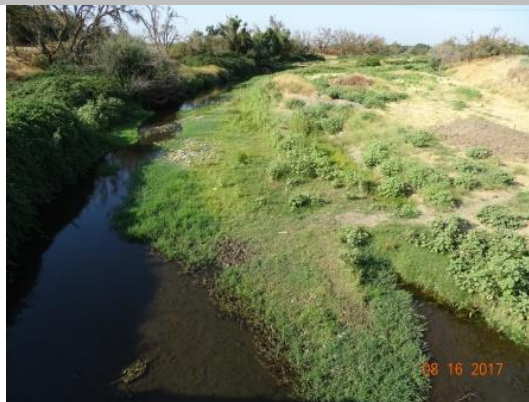
Inspector Comments: There is vegetation present downstream of bridge crossing, left bank; wild growth of berries needs removal.

Bonner Road looking downstream. Summer 2018

Bonner Road looking downstream.

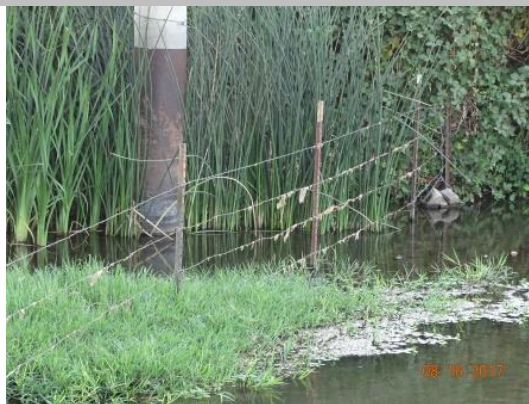
Inspector Comments: There is a fence across the channel under the bridge which may impede flow.

View of the fence in the channel.

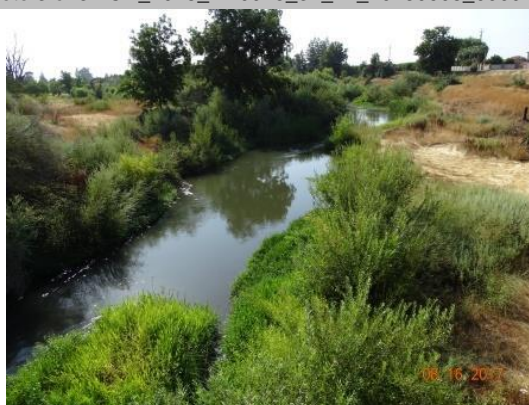
Inspector Comments: There is growth in the channel and vegetation on the left bank upstream of crossing. Recommend clearing vegetation at least 100ft upstream from the bridge.

Arboleda Drive crossing Bear Creek looking upstream.

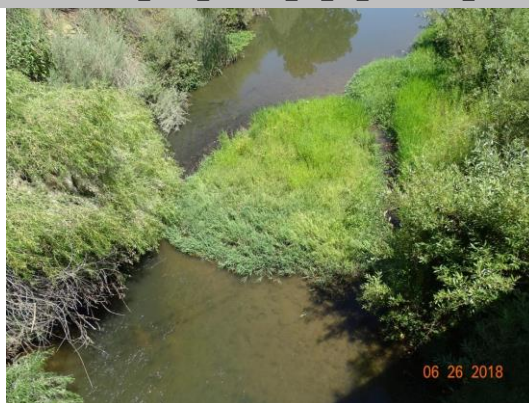
Inspector Comments: There is shoaling with vegetation present in the channel.

There is shoaling with vegetation present in the channel. Summer 2018.

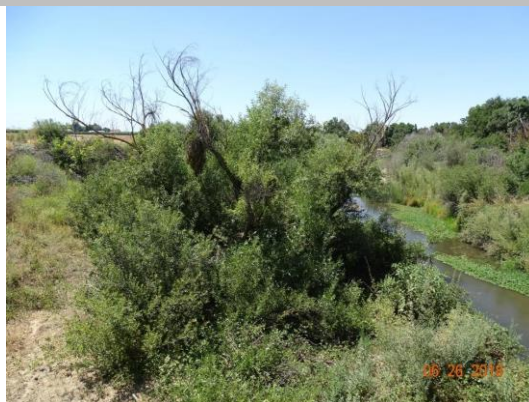
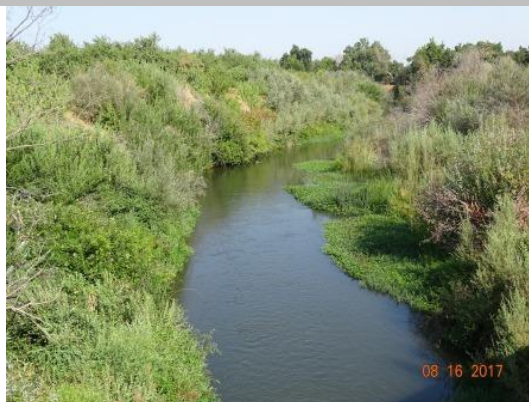
Inspector Comments: There is vegetation present on both banks of crossing. Recommend clearing vegetation at least 100ft downstream from the bridge.

Arboleda Drive Bridge, crossing the Bear Creek looking downstream.
Summer 2018

Arboleda Drive Bridge, crossing the Bear Creek looking downstream.

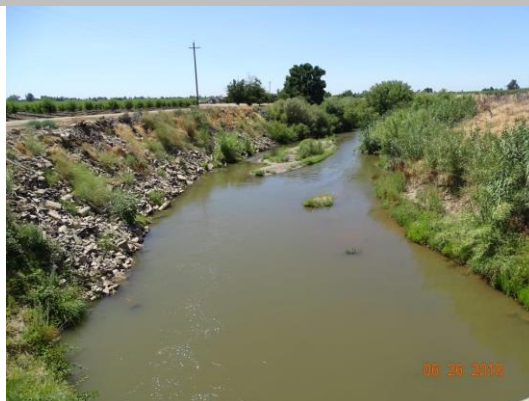
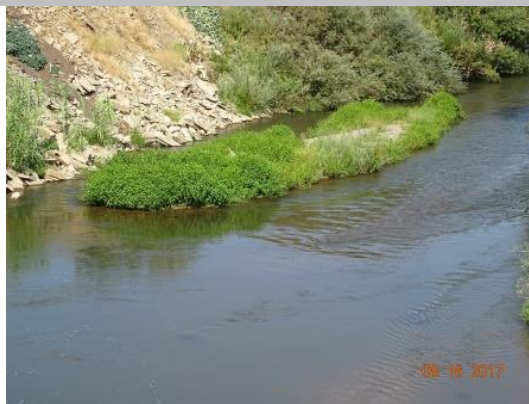
Rating **	M	Issue No.	37	GPS Lat/Long
Issue Type +	Ma	Location *		37.312195 °
Category	Rivers, Channels & Designated Flood			-120.414967 °
Item	Shoaling / Sedimentation			
DWR ID	DWR_NA0013_32_c_2016_37			
Action/Comments				
Inspector Comments: There is shoaling downstream from the bridge crossing with grasses and brush growing on it.

Shoaling with vegetation present downstream from the bridge. Summer 2018

Kibby Road crossing the Bear Creek looking downstream from the Bridge, shoaling is present in the channel.

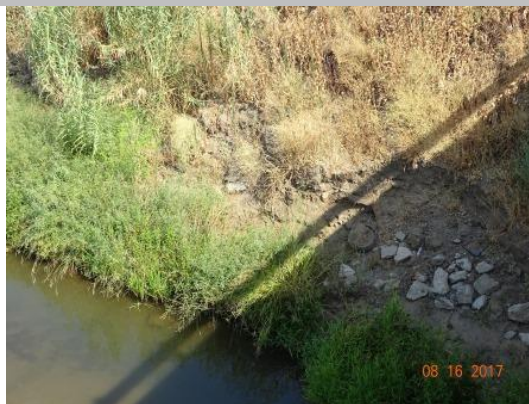
Inspector Comments: There is some erosion on the right bank of the channel.

View of erosion on right bank of channel downstream of the bridge.
Summer 2018

View of the erosion in the channel.

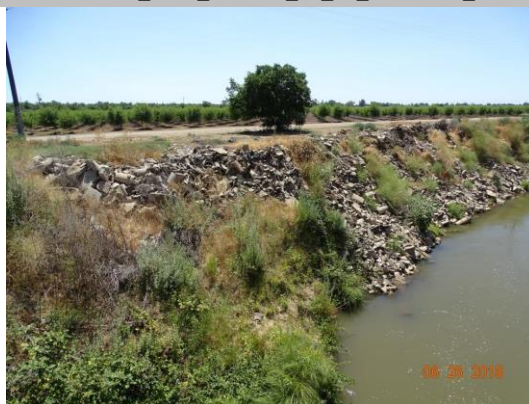
Inspector Comments: There is riprap placed on the left bank slope downstream from the Kibby Road crossing.

Riprap protection on left bank downstream of the crossing is clearly visible. Summer 2018

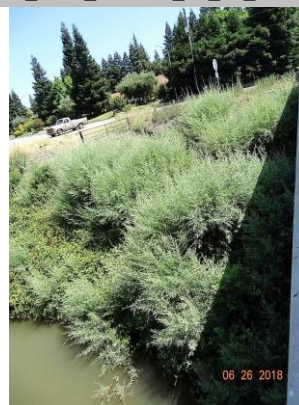
Bear Creek upstream of McKee Rd crossing. Overgrown brush underneath crossing. Summer 2018

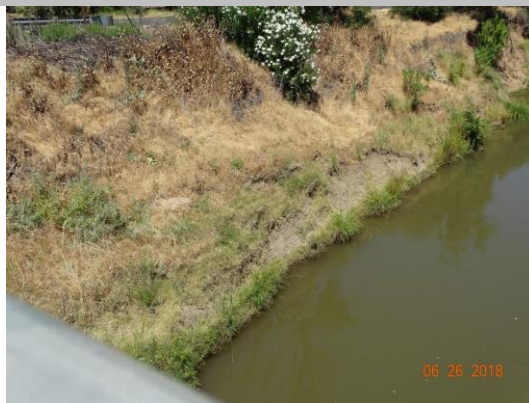
Inspector Comments: Erosion still present on the right bank upstream of the McKee Rd. Bank should be repaired before Flood Season.

View of erosion on the right bank upstream of the McKee Road bridge.
Summer 2018

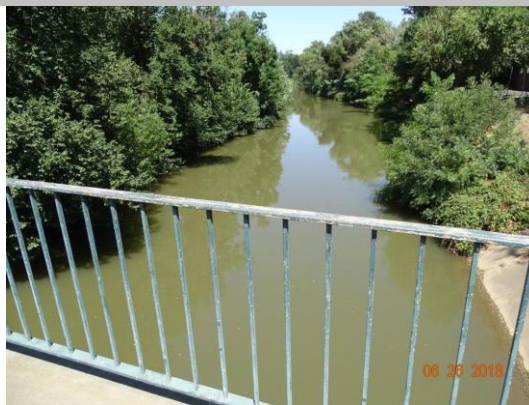
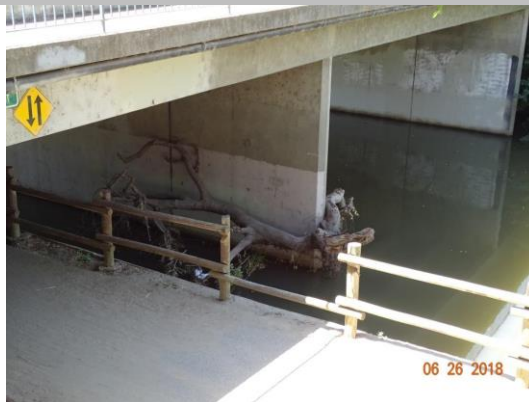
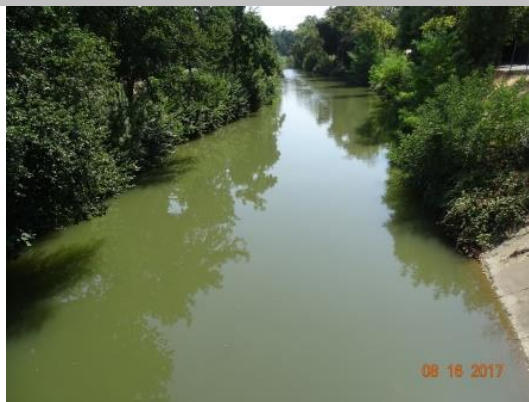
Inspector Comments: Some woody vegetation on the banks of the channel which does not appear to impede flow. Dead tree remains underneath the R St. bridge.

Dead tree remains underneath R St. crossing. Summer 2018

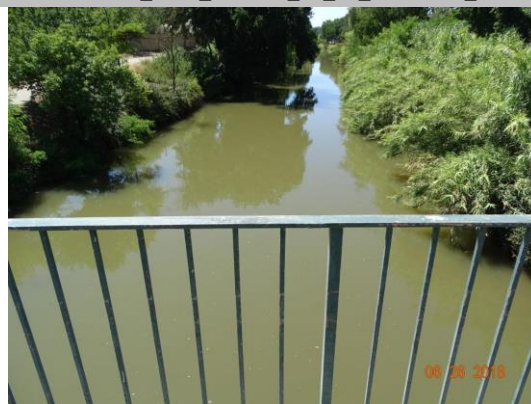
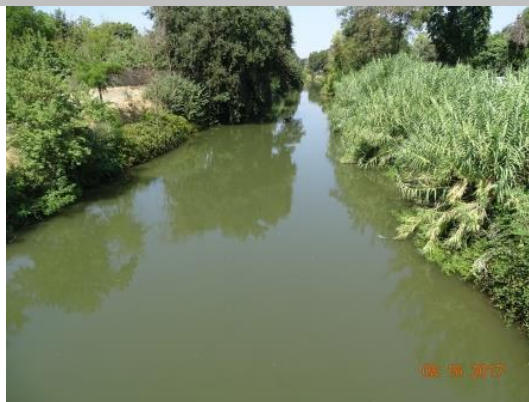
Inspector Comments: Some woody vegetation on the banks which does not appear to impede flow. The arundo on the right bank needs to be controlled.

Bear Creek looking downstream from R street bridge crossing. Summer 2018

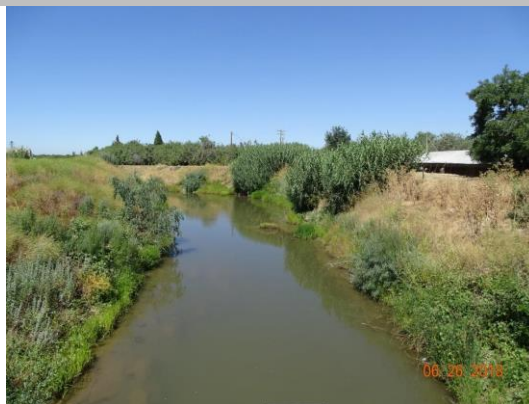
Rating **	A	Issue No.	66	GPS Lat/Long
Issue Type +	Ma	Location *		37.311486 °
Category	Rivers, Channels & Designated Flood			-120.541088 °
Item	Vegetation & Obstructions			
DWR ID	DWR_NA0013_32_c_2016_66			
Action/Comments				
Inspector Comments: Some woody vegetation on the banks of the channel which does not appear to impede flow but should be managed.

Bear Creek looking downstream from Franklin Road crossing. Summer 2018

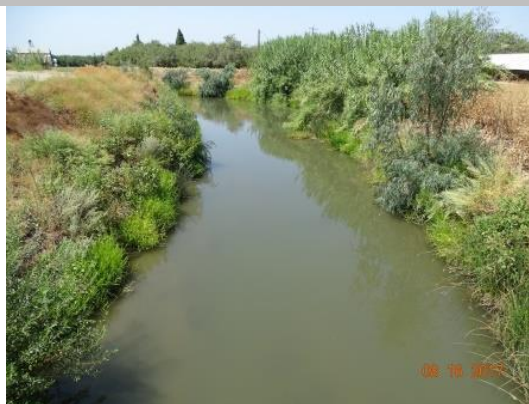
Photo 2 of 2 : CH_2018_NA0013_32_66_20180608_00016.jpg

Bear Creek looking downstream from Franklin Road crossing.

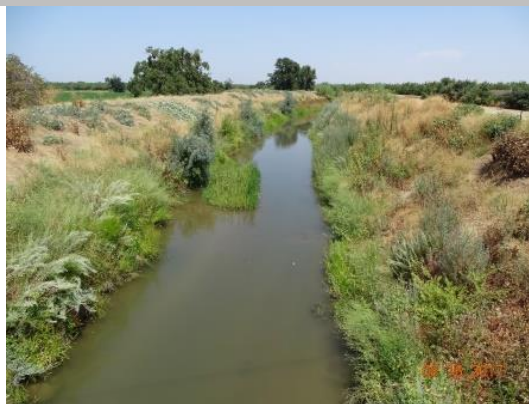
Photo 2 of 2 : CH_2018_NA0013_32_71_20180608_00017.jpg

Bear Creek looking upstream from Hwy 140 bridge crossing.

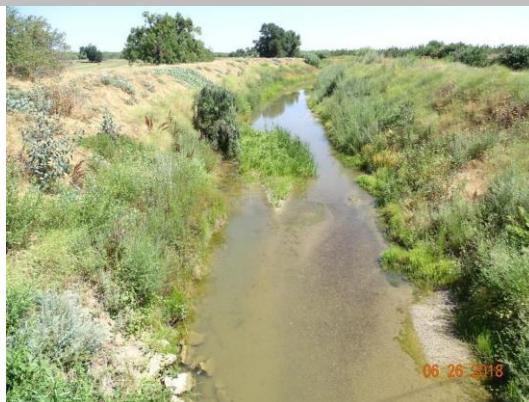
Photo 1 of 1 : CH_2018_NA0013_32_72_20180709_00057.jpg

Rating **	M	Issue No.	72	GPS Lat/Long
Issue Type +	Ma	Location *		37.302576 °
Category	Rivers, Channels & Designated Flood			-120.551477 °
Item	Shoaling / Sedimentation			
DWR ID	DWR_NA0013_32_c_2016_72			
Action/Comments				
Inspector Comments: Shoaling is present in channel at this location with vegetation growth established.

Shoaling and sedimentation present in channel upstream of Hwy 140 crossing. Summer 2018

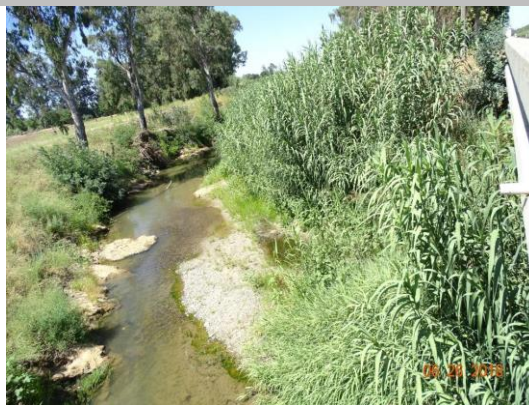
Photo 1 of 2 : CH_2018_NA0013_32_76_20180709_00058.jpg

Check Point / View				
Hwy 140 / Down				
Rating **	M	Issue No.	76	GPS Lat/Long
Issue Type +	Ma	Location *		37.302576 °
Category	Rivers, Channels & Designated Flood			-120.551477 °
Item	Vegetation & Obstructions			
DWR ID	DWR_NA0013_32_c_2018_76			
Action/Comments				
Inspector Comments: Wild growth in the channel downstream of and underneath bridge should be controlled.

Bear Creek looking downstream from Hwy 140 bridge crossing.
Summer 2018

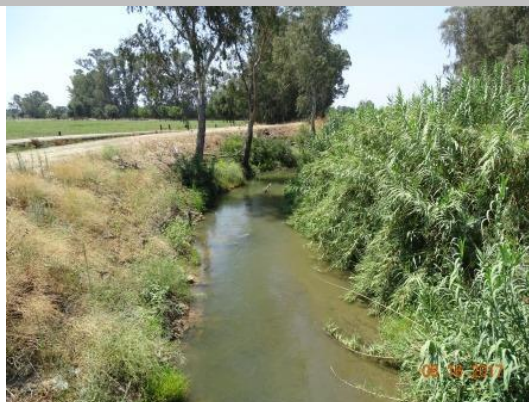
Photo 2 of 2 : CH_2018_NA0013_32_76_20180608_00018.jpg

Rating **	M	Issue No.	76 (cont)	GPS Lat/Long
Issue Type +	Ma	Location *		37.302576 °
Category	Rivers, Channels & Designated Flood			-120.551477 °
Item	Vegetation & Obstructions			
DWR ID	DWR_NA0013_32_c_2018_76			
Action/Comments				
Inspector Comments: Wild growth in the channel downstream of and underneath bridge should be controlled.

Bear Creek looking downstream from Hwy 140 bridge crossing.

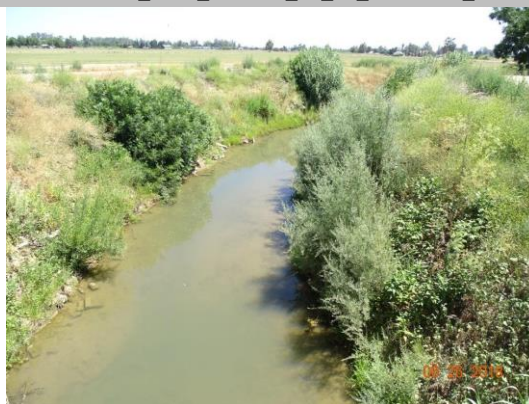
Photo 1 of 2 : CH_2018_NA0013_32_81_20180709_00061.jpg

Rating **	M	Issue No.	81	GPS Lat/Long
Issue Type +	Ma	Location *		37.291282 °
Category	Rivers, Channels & Designated Flood			-120.577961 °
Item	Vegetation & Obstructions			
DWR ID	DWR_NA0013_32_c _ 2016_81			
Action/Comments				
Inspector Comments: The vegetation in the channel should be controlled.

Bear Creek looking upstream from Buhach Road crossing. Summer 2018

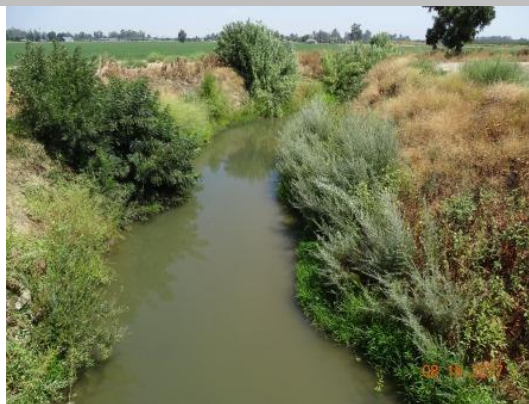
Photo 2 of 2 : CH_2018_NA0013_32_81_20180608_00019.jpg

Rating **	M	Issue No.	81 (cont)	GPS Lat/Long
Issue Type +	Ma	Location *		37.291282 °
Category	Rivers, Channels & Designated Flood			-120.577961 °
Item	Vegetation & Obstructions			
DWR ID	DWR_NA0013_32_c_2016_81			
Action/Comments				
Inspector Comments: The vegetation in the channel should be controlled.

Bear Creek looking upstream from Buhach Road crossing.

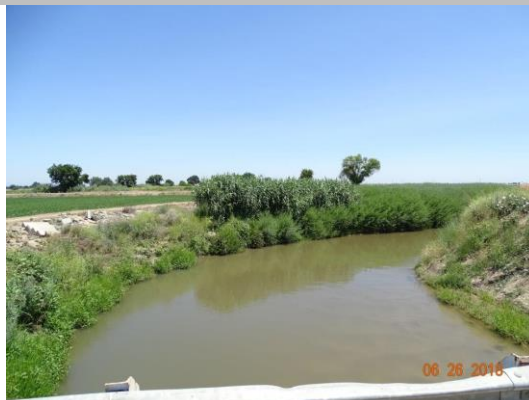
Photo 1 of 2 : CH_2018_NA0013_32_101_20180709_00064.jpg

Inspector Comments: Some vegetation present on the channel banks but does not appear to impede flow upstream of the bridge.

Bear Creek looking upstream from Bert Crane Rd. crossing. Summer 2018

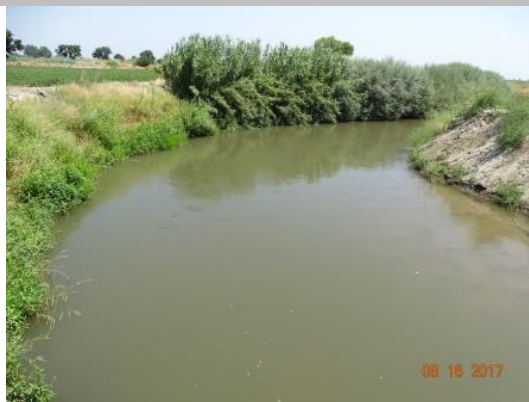
Photo 2 of 2 : CH_2018_NA0013_32_101_20180608_00021.jpg

Inspector Comments: Some vegetation present on the channel banks but does not appear to impede flow upstream of the bridge.

Bear Creek looking upstream from Bert Crane Rd. crossing.

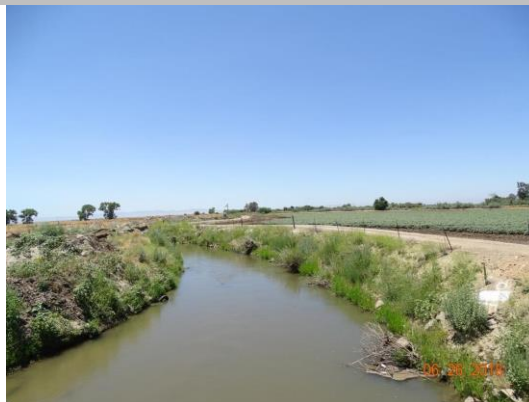
Photo 1 of 2 : CH_2018_NA0013_32_106_20180709_00065.jpg

Inspector Comments: Some vegetation present on the channel banks but does not appear to impede flow downstream of the bridge.

Bear Creek looking downstream from Bert Crane Road crossing.
Summer 2018

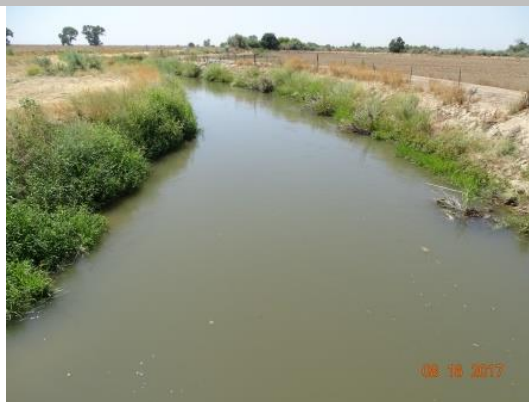
Photo 2 of 2 : CH_2018_NA0013_32_106_20180608_00022.jpg

Inspector Comments: Some vegetation present on the channel banks but does not appear to impede flow downstream of the bridge.

Bear Creek looking downstream from Bert Crane Road crossing.

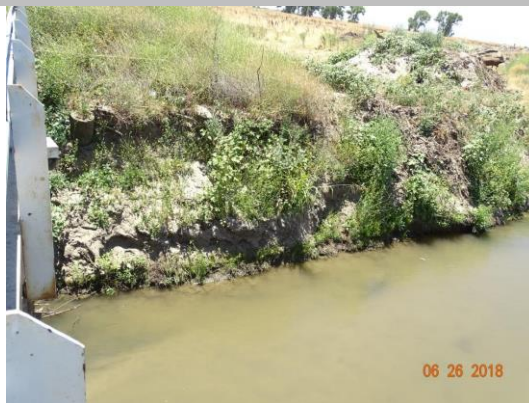
Photo 1 of 1 : CH_2018_NA0013_32_108_20180709_00066.jpg

Inspector Comments: Erosion on the left bank downstream of the bridge does not appear to affect channel capacity at this time.

View of erosion on left bank downstream of the Bert Crane Rd crossing.
Summer 2018

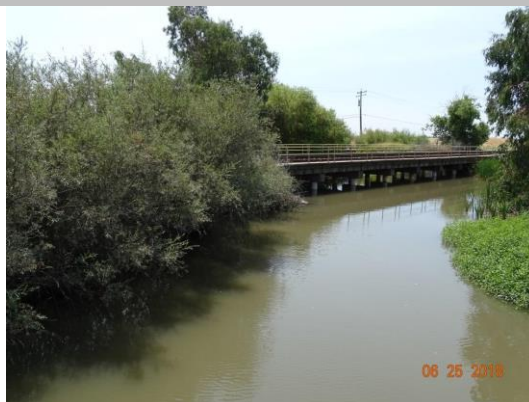
Photo 1 of 1 : CH_2018_NA0013_33_6_20180706_00023.jpg

Inspector Comments: There is vegetation in the channel, but it does not appear to impede the capacity of the channel at this time.

Santa Fe Drive crossing Black Rascal Creek. Summer 2018.

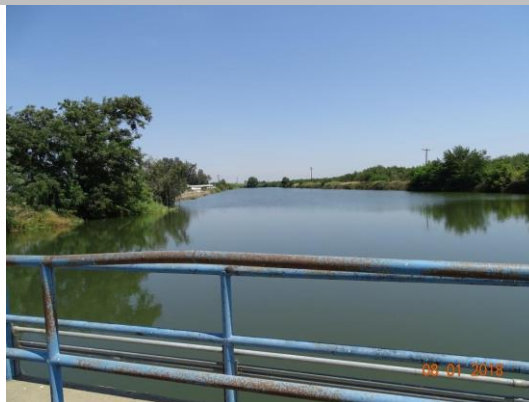
Photo 1 of 2 : CH_2018_NA0013_33_11_20180803_00053.jpg

View of vegetation along right bank. Summer 2018

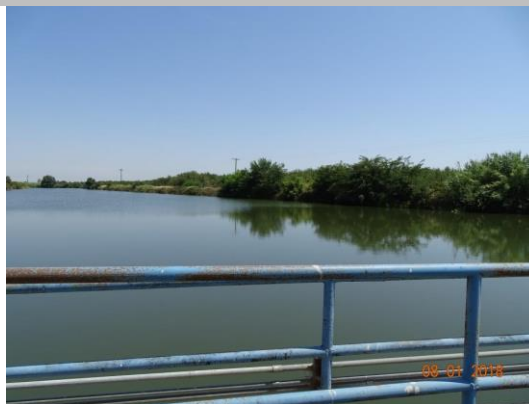
Photo 2 of 2 : CH_2018_NA0013_33_11_20180803_00054.jpg

View of vegetation along left bank. Summer 2018

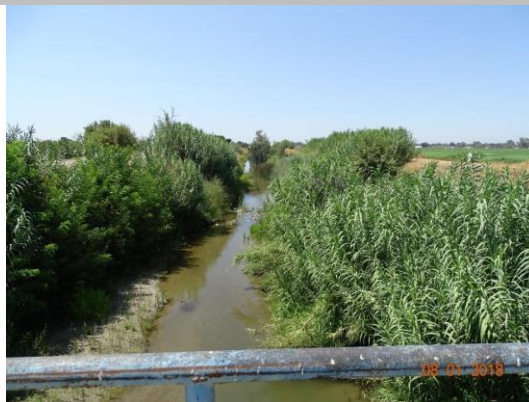
Photo 1 of 2 : CH_2018_NA0013_33_16_20180803_00055.jpg

Rating **	M	Issue No.	16	GPS Lat/Long
Issue Type +	Ma	Location *		37.312458 °
Category	Rivers, Channels & Designated Flood			-120.532708 °
Item	Vegetation & Obstructions			
DWR ID	DWR_NA0013_33_c_2016_16			
Action/Comments				
Inspector Comments: Some improvements have been made, but Arundo still needs to be eradicated from area.

View of Arundo along right bank. Summer 2018

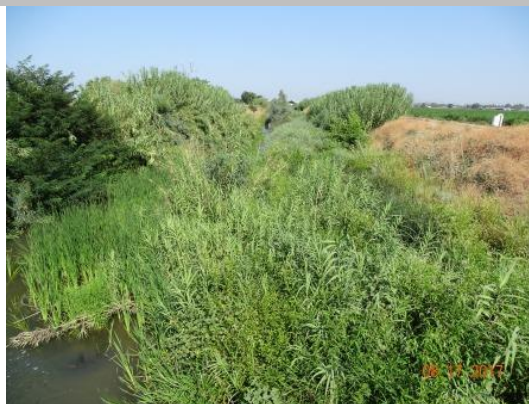
Photo 2 of 2 : CH_2018_NA0013_33_16_20180608_00004.jpg

Inspector Comments: Some improvements have been made, but Arundo still needs to be eradicated from area.

View of Arundo along right bank. Summer 2017

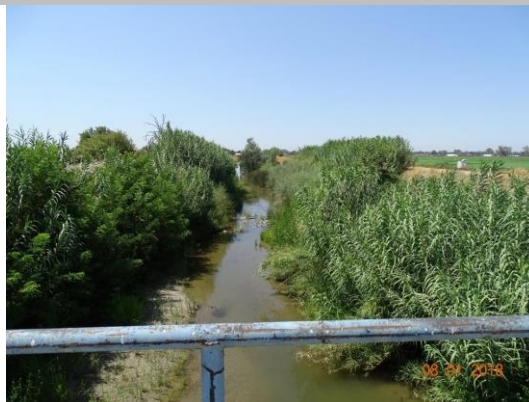
Photo 1 of 3 : CH_2018_NA0013_33_17_20180803_00056.jpg

Inspector Comments: Shoaling is present right at the downstream end of the outlet.

View of shoaling along left bank. Summer 2018

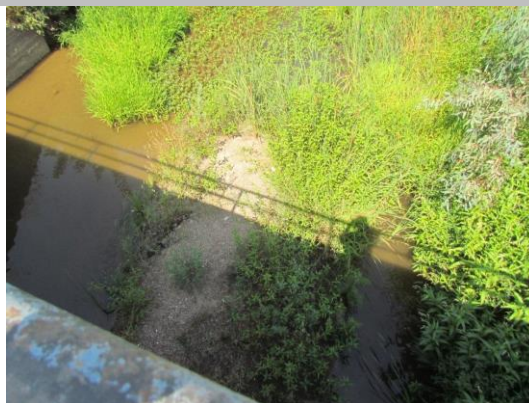
Photo 2 of 3 : CH_2018_NA0013_33_17_20180608_00006.jpg

Shoal present downstream from the Crocker Dam. Summer 2017

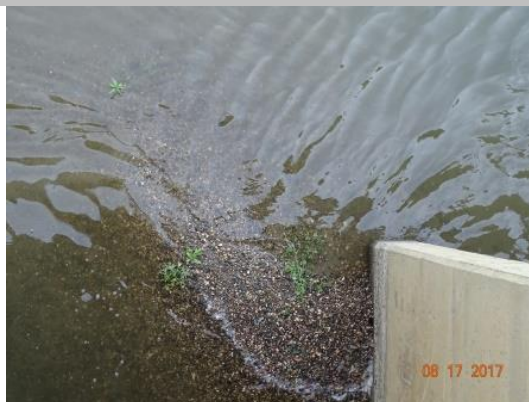
Photo 3 of 3 : CH_2018_NA0013_33_17_20180608_00005.jpg

Inspector Comments: Shoaling is present right at the downstream end of the outlet.

Another view of the sediment in the channel. Summer 2017

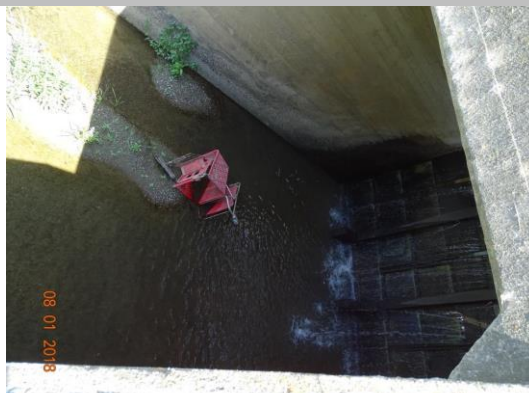
Photo 1 of 1 : CH_2018_NA0013_33_20_20180803_00057.jpg

Inspector Comments: The debris needs to be removed from the channel.

View of a grocery cart in the channel. Summer 2018

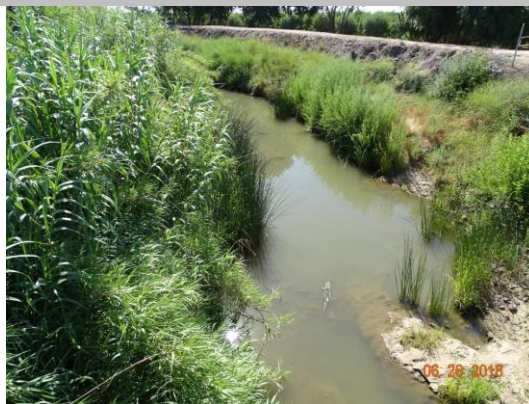
Photo 1 of 3 : CH_2018_NA0013_33_21_20180706_00027.jpg

Inspector Comments: The wild growth present in the channel needs to be controlled.

View of overgrown vegetation on right bank. Summer 2018

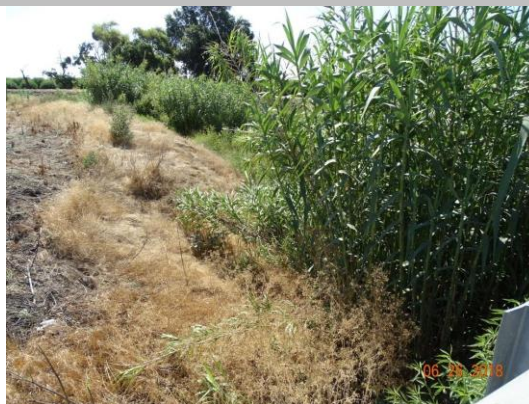
Photo 2 of 3 : CH_2018_NA0013_33_21_20180706_00028.jpg

View of overgrown vegetation along left bank. Summer 2018

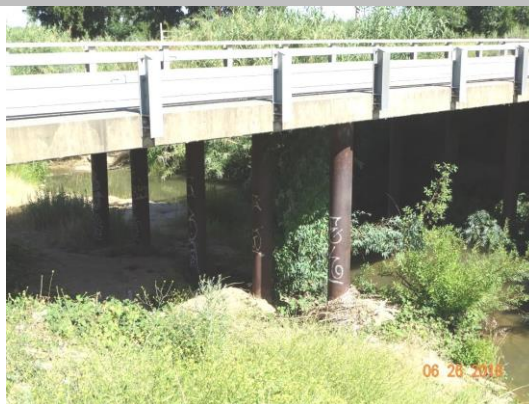
Photo 1 of 1 : CH_2018_NA0013_33_22_20180706_00029.jpg

Inspector Comments: There is shoaling with brush underneath the crossing, but flow does not appear to be impeded.

Shoaling with vegetation present upstream of and underneath Franklin Road crossing. Summer 2018

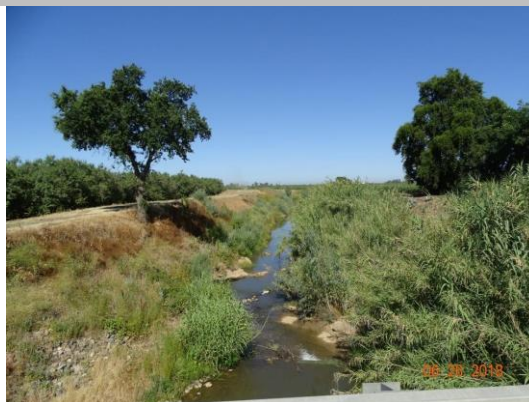
Photo 1 of 3 : CH_2018_NA0013_33_26_20180706_00030.jpg

Rating **	M	Issue No.	26	GPS Lat/Long
Issue Type +	Ma	Location *		37.314050 °
Category	Rivers, Channels & Designated Flood			-120.541078 °
Item	Vegetation & Obstructions			
DWR ID	DWR_NA0013_33_c_2016_26			
Action/Comments				
Inspector Comments: The channel is overgrown with arundo and other wild growth that needs to be controlled.

Black Rascal Creek looking downstream from Franklin Road crossing.
Summer 2018

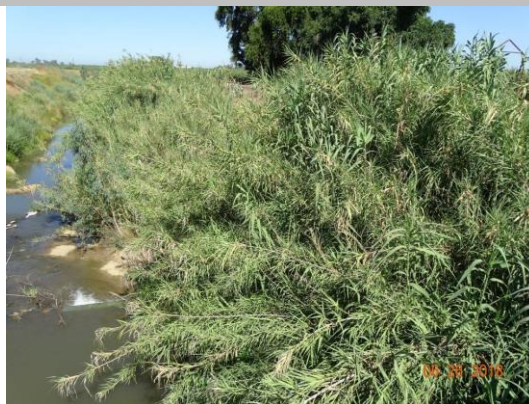
Photo 2 of 3 : CH_2018_NA0013_33_26_20180706_00031.jpg

Rating **	M	Issue No.	26 (cont)	GPS Lat/Long
Issue Type +	Ma	Location *		37.314050 °
Category	Rivers, Channels & Designated Flood			-120.541078 °
Item	Vegetation & Obstructions			
DWR ID	DWR_NA0013_33_c_2016_26			
Action/Comments				
Inspector Comments: The channel is overgrown with arundo and other wild growth that needs to be controlled.

Black Rascal Creek looking downstream from Franklin Road crossing.
Summer 2018

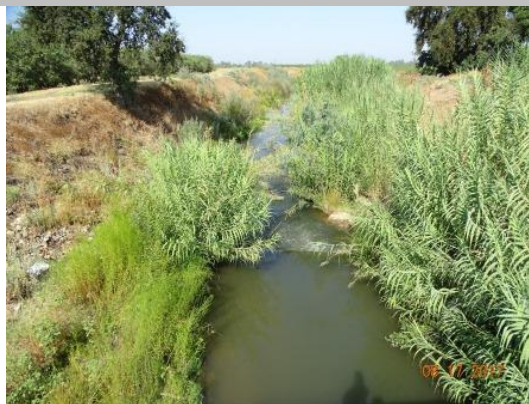
Photo 3 of 3 : CH_2018_NA0013_33_26_20180608_00008.jpg

Black Rascal Creek looking downstream from Franklin Road crossing.

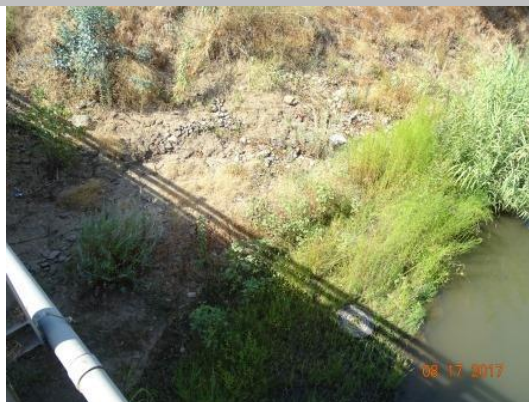
Photo 2 of 2 : CH_2018_NA0013_33_27_20180608_00009.jpg

Black Rascal Creek looking downstream from Franklin Road crossing.

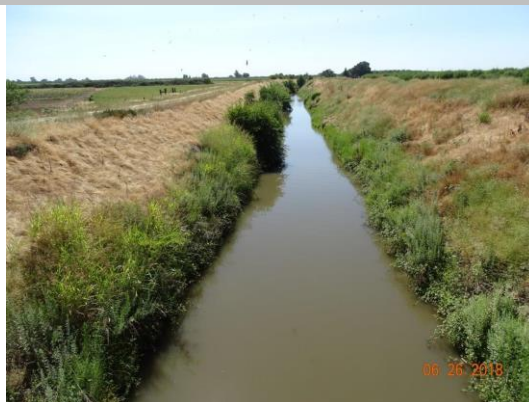
Photo 1 of 3 : CH_2018_NA0013_33_31_20180706_00033.jpg

Inspector Comments: Brush underneath the crossing needs to be controlled, but vegetation does not appear to impede flow.

Black Rascal Creek looking upstream from Gurr Road crossing.
Summer 2018

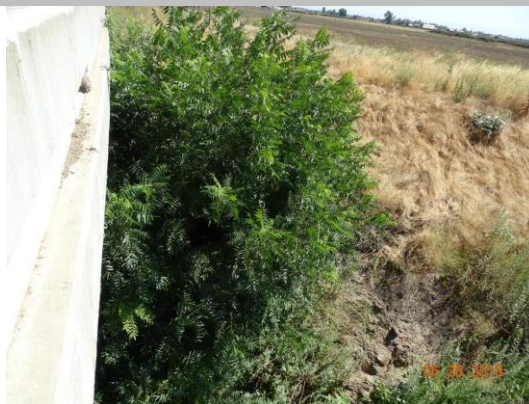
Photo 2 of 3 : CH_2018_NA0013_33_31_20180706_00034.jpg

Inspector Comments: Brush underneath the crossing needs to be controlled, but vegetation does not appear to impede flow.

Black Rascal Creek upstream from Gurr Road crossing. Brush growing underneath crossing needs to be removed. Summer 2018

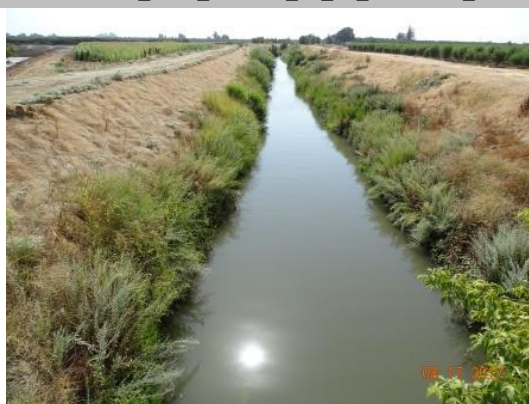
Photo 3 of 3 : CH_2018_NA0013_33_31_20180608_00010.jpg

Black Rascal Creek looking upstream from Gurr Road crossing.

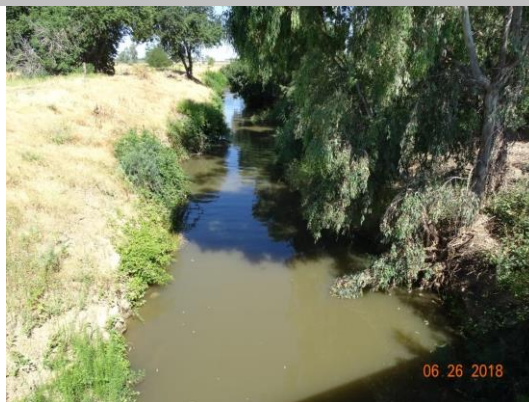
Photo 1 of 2 : CH_2018_NA0013_33_36_20180706_00035.jpg

Rating **	U	Issue No.	36	GPS Lat/Long
Issue Type +	Ma	Location *		37.313110 °
Category	Rivers, Channels & Designated Flood			-120.559070 °
Item	Vegetation & Obstructions			
DWR ID	DWR_NA0013_33_c_2016_36			
Action/Comments				
Inspector Comments: The wild growth on the right bank needs to be removed as its extending into the channel making it hard to inspect.

Black Rascal Creek looking downstream from Gurr Road crossing.
Summer 2018

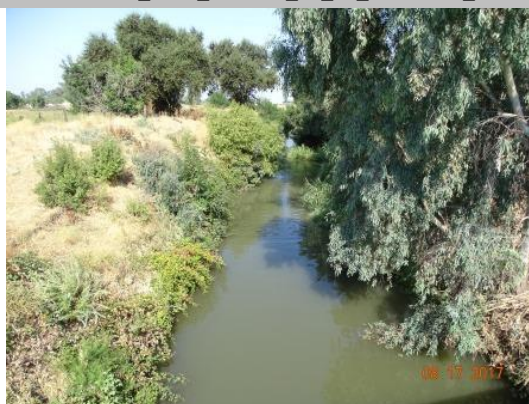
Photo 2 of 2 : CH_2018_NA0013_33_36_20180608_00012.jpg

Black Rascal Creek looking downstream from Gurr Road crossing.

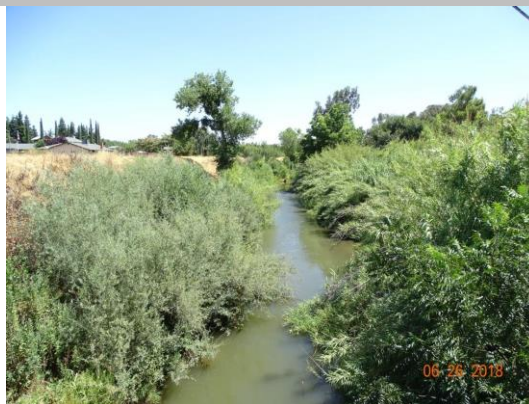
Photo 1 of 3 : CH_2018_NA0013_33_41_20180706_00036.jpg

Rating **	U	Issue No.	41	GPS Lat/Long
Issue Type +	Ma	Location *		37.302329 °
Category	Rivers, Channels & Designated Flood			-120.575613 °
Item	Vegetation & Obstructions			
DWR ID	DWR_NA0013_33_c_2016_41			
Action/Comments				
Inspector Comments: Arundo is taking over the channel and should be removed.

View of Black Rascal Creek upstream of the Hwy 140 crossing.
Summer 2018

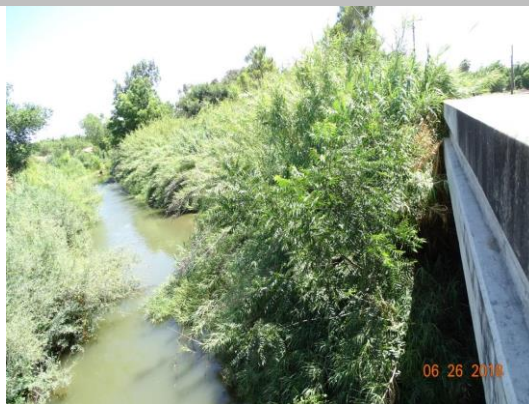
Photo 2 of 3 : CH_2018_NA0013_33_41_20180706_00037.jpg

View of Black Rascal Creek upstream of the Hwy 140 crossing.
Overgrown brush adjacent to crossing. Summer 2018

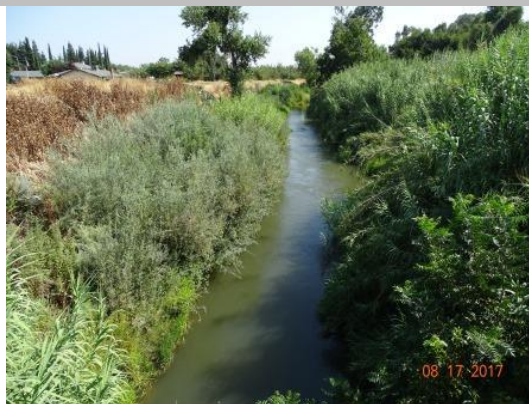
Photo 3 of 3 : CH_2018_NA0013_33_41_20180608_00013.jpg

Black Rascal Creek from the Hwy 140 crossing the channel.

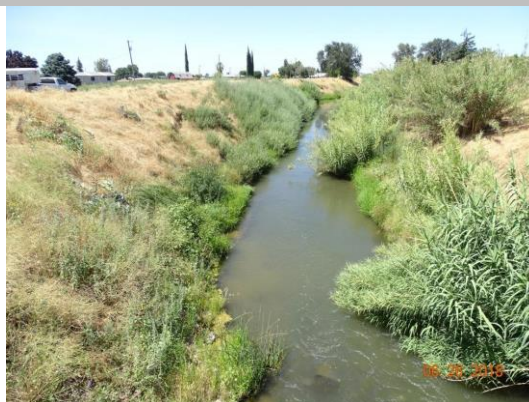
Photo 1 of 2 : CH_2018_NA0013_33_46_20180706_00038.jpg

Check Point / View				
Hwy 140 / Down				
Rating **	M	Issue No.	46	GPS Lat/Long
Issue Type +	Ma	Location *		37.302329 °
Category	Rivers, Channels & Designated Flood			-120.575613 °
Item	Vegetation & Obstructions			
DWR ID	DWR_NA0013_33_c_2016_46			
Action/Comments				
Inspector Comments: Some improvements on left bank, but overgrown brush still on right side of channel. Summer 2018

Black Rascal Creek looking downstream from Hwy 140 crossing.
Summer 2018

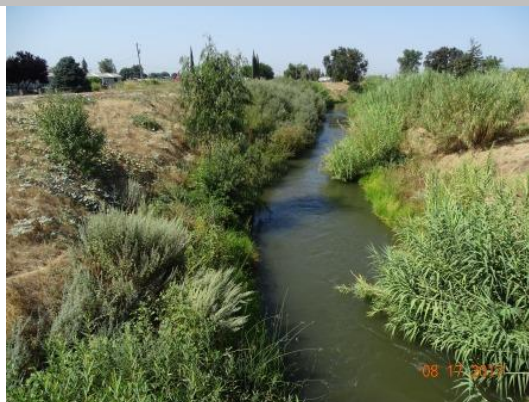
Photo 2 of 2 : CH_2018_NA0013_33_46_20180608_00014.jpg

Rating **	M	Issue No.	46 (cont)	GPS Lat/Long
Issue Type +	Ma	Location *		37.302329 °
Category	Rivers, Channels & Designated Flood			-120.575613 °
Item	Vegetation & Obstructions			
DWR ID	DWR_NA0013_33_c _ 2016_46			
Action/Comments				
Inspector Comments: Some improvements on left bank, but overgrown brush still on right side of channel. Summer 2018

Black Rascal Creek looking downstream from Hwy 140 crossing.

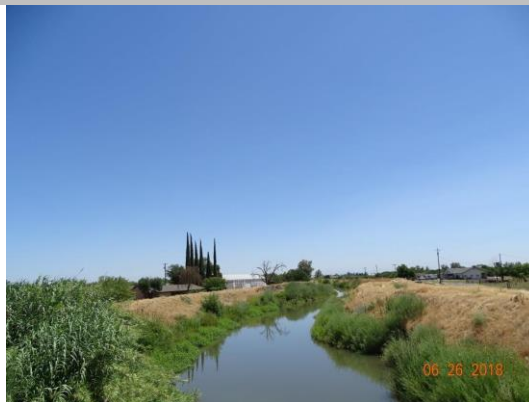
Photo 1 of 3 : CH_2018_NA0013_33_51_20180706_00039.jpg

Rating **	M	Issue No.	51	GPS Lat/Long
Issue Type +	Ma	Location *		37.293797 °
Category	Rivers, Channels & Designated Flood			-120.596922 °
Item	Vegetation & Obstructions			
DWR ID	DWR_NA0013_33_c _ 2016_51			
Action/Comments				
Inspector Comments: Control the vegetation growth in the channel and banks.

Black Rascal Creek upstream from Quinley Road crossing. Summer 2018

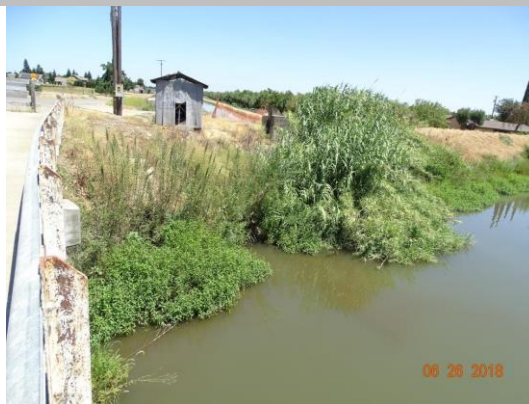
Photo 2 of 3 : CH_2018_NA0013_33_51_20180706_00040.jpg

Inspector Comments: Control the vegetation growth in the channel and banks.

Black Rascal Creek upstream from Quinley Road crossing. Vegetation and brush adjacent to crossing. Summer 2018

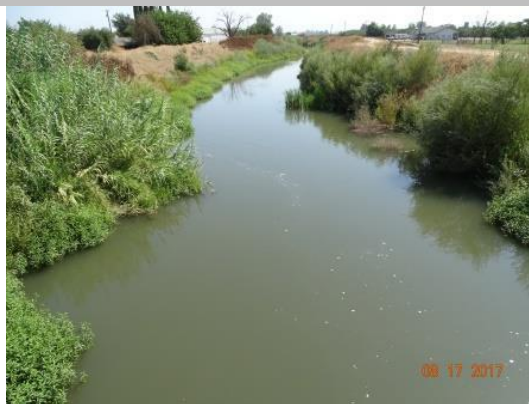
Photo 3 of 3 : CH_2018_NA0013_33_51_20180608_00015.jpg

Black Rascal Creek from Quinley Road crossing.

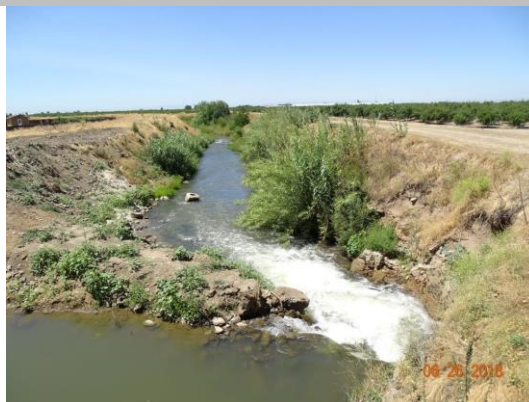
Photo 1 of 2 : CH_2018_NA0013_33_56_20180706_00042.jpg

Rating **	M	Issue No.	56	GPS Lat/Long
Issue Type +	Ma	Location *		37.293797 °
Category	Rivers, Channels & Designated Flood			-120.596922 °
Item	Vegetation & Obstructions			
DWR ID	DWR_NA0013_33_c_2016_56			
Action/Comments				
Inspector Comments: Control the growth in the channel.

Black Rascal Creek from Quinley Rd. crossing looking downstream.
Summer 2018

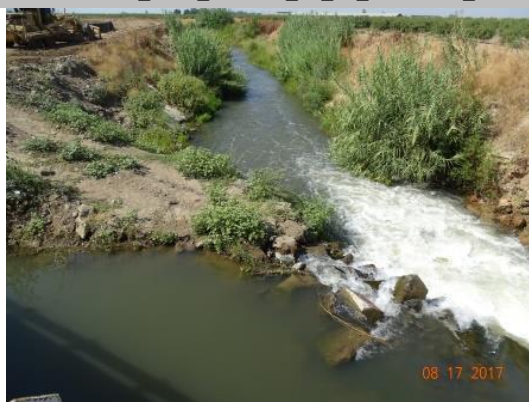
Photo 2 of 2 : CH_2018_NA0013_33_56_20180608_00016.jpg

Black Rascal Creek from Quinley Rd. crossing looking downstream.

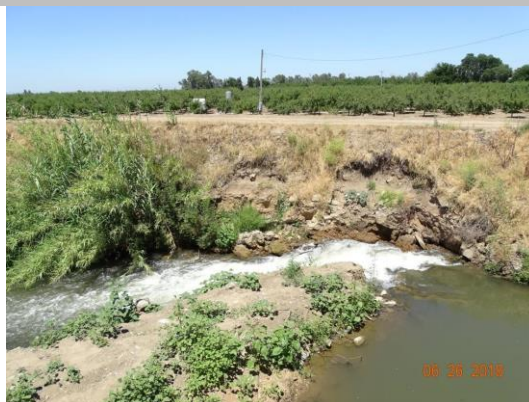
Photo 1 of 1 : CH_2018_NA0013_33_58_20180706_00043.jpg

Rating **	U	Issue No.	58	GPS Lat/Long
Issue Type +	Ma	Location *		37.293797 °
Category	Rivers, Channels & Designated Flood			-120.596922 °
Item	Erosion / Bank Caving			
DWR ID	DWR_NA0013_33_c_2016_58			
Action/Comments				
Inspector Comments: Significant erosion due to encroachment in the channel.

Significant erosion downstream of Quinley Rd. crossing on right bank.
Summer 2018

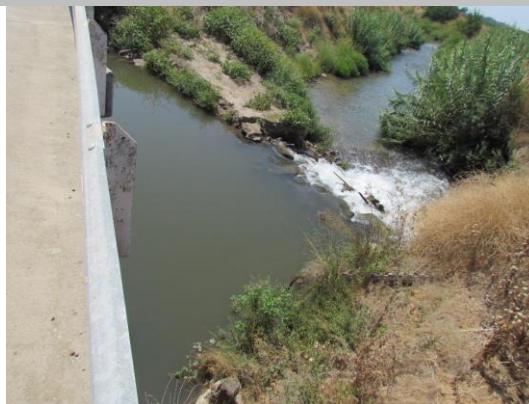
Photo 2 of 2 : CH_2018_NA0013_33_60_20180608_00017.jpg

Inspector Comments: This rock dam was not removed since last inspection and caused significant erosion of right bank. Summer 2018

Black Rascal Creek looking downstream from Quinley Rd. crossing.
Rock dam has been installed.

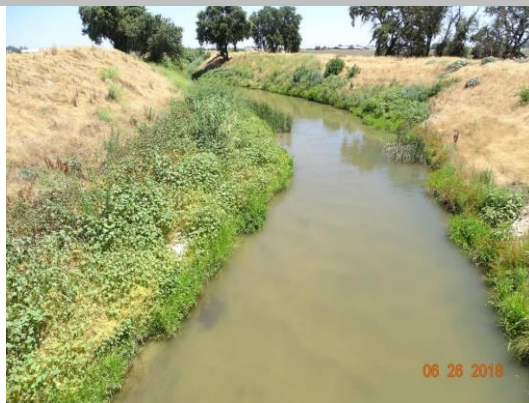
Photo 1 of 3 : CH_2018_NA0013_33_61_20180706_00046.jpg

Inspector Comments: Brush near the bridge needs to be controlled, but vegetation does not appear to impede flow.

Black Rascal Creek from Oak Avenue crossing. Summer 2018

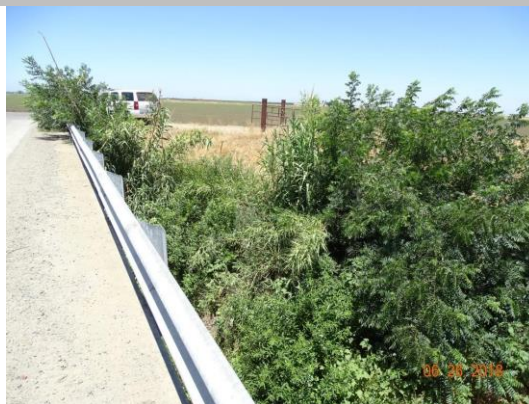
Photo 2 of 3 : CH_2018_NA0013_33_61_20180706_00045.jpg

Inspector Comments: Brush near the bridge needs to be controlled, but vegetation does not appear to impede flow.

Black Rascal Creek from Oak Avenue crossing. Overgrown brush adjacent to crossing. Summer 2018

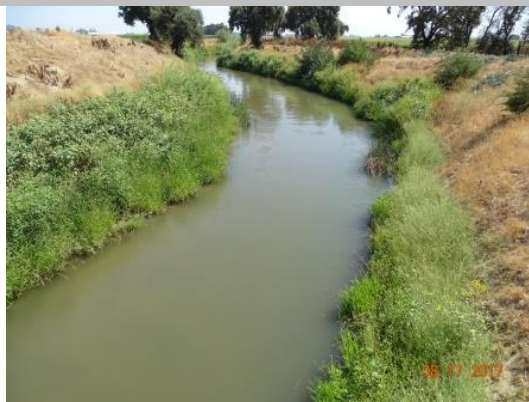
Photo 3 of 3 : CH_2018_NA0013_33_61_20180608_00018.jpg

Black Rascal Creek from Oak Avenue crossing.

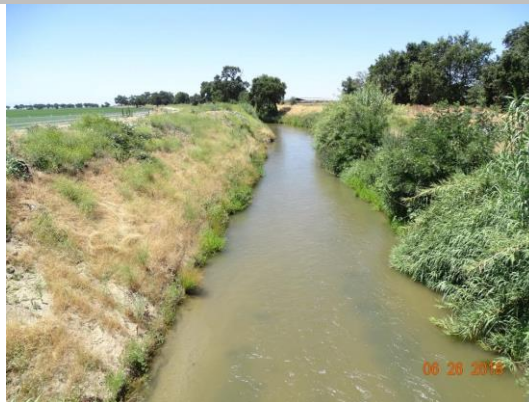
Photo 1 of 3 : CH_2018_NA0013_33_66_20180706_00047.jpg

Rating **	A	Issue No.	66	GPS Lat/Long
Issue Type +	Ma	Location *		37.280330 °
Category	Rivers, Channels & Designated Flood			-120.609400 °
Item	Vegetation & Obstructions			
DWR ID	DWR_NA0013_33_c_2018_66			
Action/Comments				
Inspector Comments: Arundo underneath crossing should be removed, but the vegetation does not appear to impede flow.

Black Rascal Creek looking downstream from Oak Avenue crossing.
Some improvements to left bank. Summer 2018

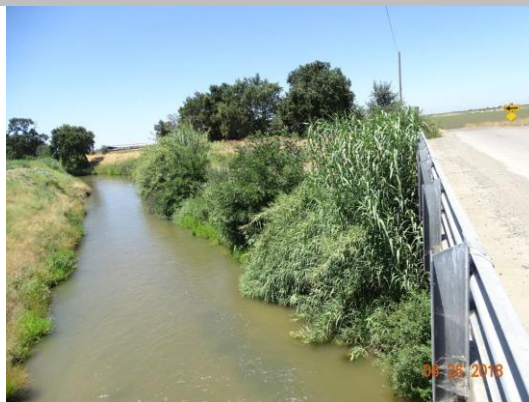
Photo 2 of 3 : CH_2018_NA0013_33_66_20180706_00048.jpg

Black Rascal Creek looking downstream from Oak Avenue crossing.
Overgrown brush underneath crossing. Summer 2018

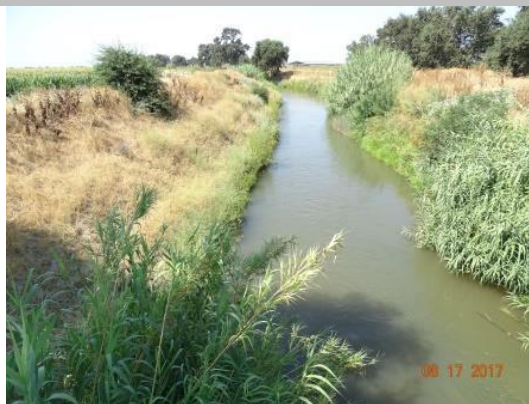
Photo 3 of 3 : CH_2018_NA0013_33_66_20180608_00019.jpg

Black Rascal Creek looking downstream from Oak Avenue crossing.

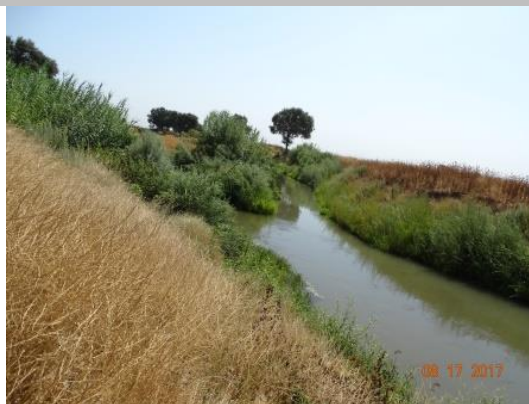
Photo 2 of 2 : CH_2018_NA0013_33_71_20180608_00020.jpg

Inspector Comments: Vegetation in the channel may impede flow.

Black Rascal Creek and the Confluence of the Bear Creek.

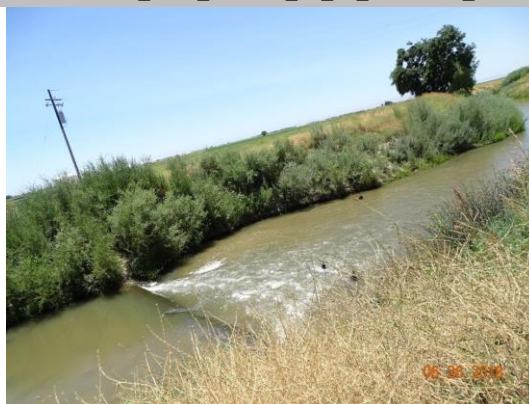
Photo 1 of 2 : CH_2018_NA0013_33_76_20180706_00051.jpg

Inspector Comments: There is minimal vegetation that does not appear to impede flow.

View of vegetation along the channel. Summer 2018

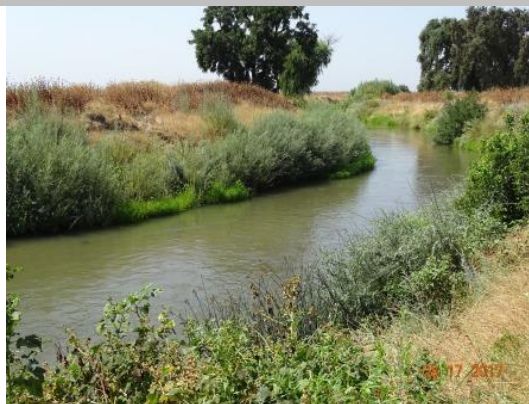
Photo 2 of 2 : CH_2018_NA0013_33_76_20180608_00021.jpg

Inspector Comments: There is minimal vegetation that does not appear to impede flow.

Looking downstream from the Bear Creek Confluence. Summer 2017

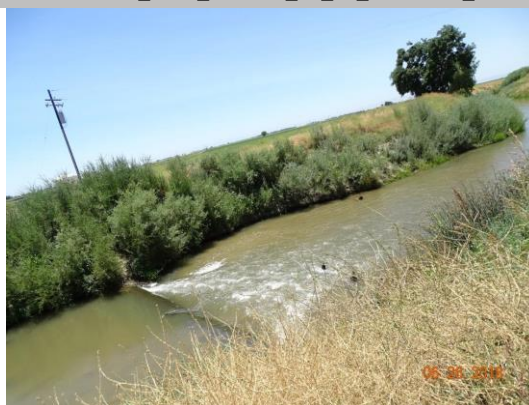
Photo 1 of 1 : CH_2018_NA0013_33_80_20180713_00052.jpg

Inspector Comments: A concrete weir structure across the channel does not appear to have a permit.

View of weir structure across channel. Summer 2018

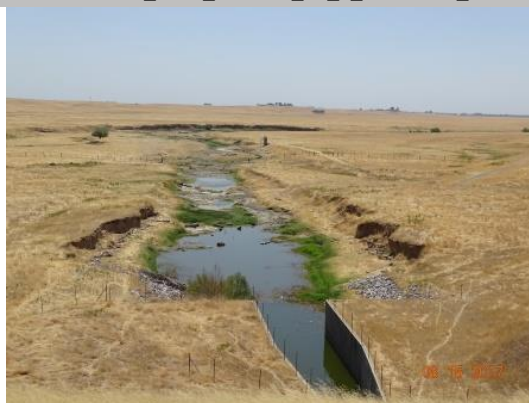
Photo 2 of 2 : CH_2018_NA0013_34_6_20180608_00002.jpg

Downstream view of Burns Creek from the top of the Burns Dam.

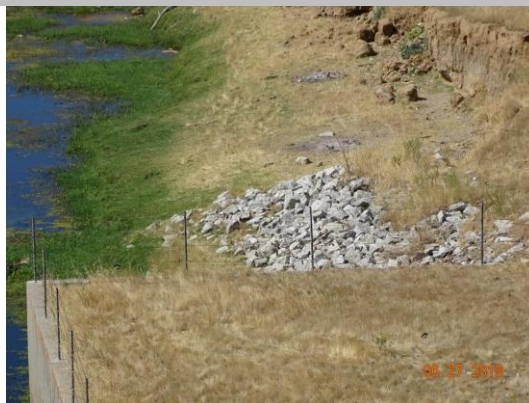
Photo 2 of 2 : CH_2018_NA0013_34_9_20180709_00009.jpg

Rating **	M	Issue No.	9 (cont)	GPS Lat/Long
Issue Type +	Ma	Location *		37.377220 °
Category	Rivers, Channels & Designated Flood			-120.276360 °
Item	Revetments			
DWR ID	DWR_NA0013_34_c_2016_9

View of revetment on right bank downstream of Burns Creek Dam.
Summer 2018

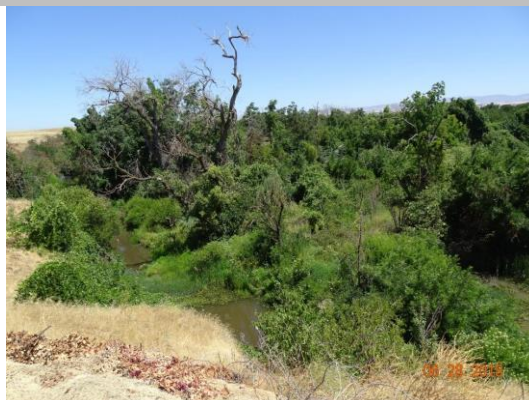
Photo 1 of 2 : CH_2018_NA0013_34_21_20180709_00011.jpg

Rating **	U	Issue No.	21	GPS Lat/Long
Issue Type +	Ma	Location *		37.333581 °
Category	Rivers, Channels & Designated Flood			-120.320642 °
Item	Vegetation & Obstructions			
DWR ID	DWR_NA0013_34_c_2016_21			
Action/Comments				
Inspector Comments: Access was very limited at this location. This photo was taken from the private property opposite of the confluence. Vegetation was never maintained and needs to be controlled or removed.

View of Burns Creek at the confluence. Summer 2018

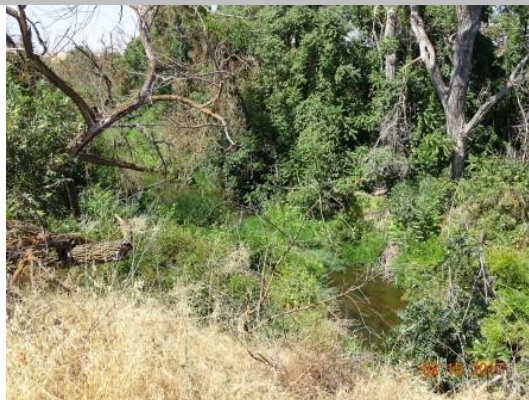
Photo 2 of 2 : CH_2018_NA0013_34_21_20180608_00003.jpg

The confluence of the Burns and Bear Creeks. Summer 2017

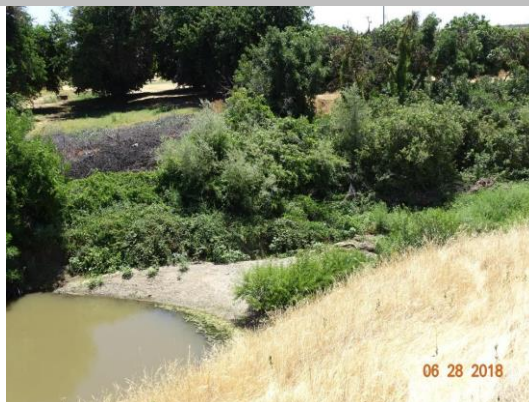
Photo 1 of 2 : CH_2018_NA0013_34_26_20180709_00014.jpg

Rating **	U	Issue No.	26	GPS Lat/Long
Issue Type +	Ma	Location *		37.333581 °
Category	Rivers, Channels & Designated Flood			-120.320642 °
Item	Vegetation & Obstructions			
DWR ID	DWR_NA0013_34_c_2016_26			
Action/Comments				
Inspector Comments: This vantage point is on private property looking across the channel. The channel is not maintained, and overgrown brush along banks needs to be controlled or removed.

The Confluence of the Burns and Bear Creeks viewed from private property on right bank. Summer 2018
